# STATE OF THE WATERSHED REPORT

## OYSTER BAY/COLD SPRING HARBOR

November 2009

**FUSS & O'NEILL**  
*Disciplines to Deliver*

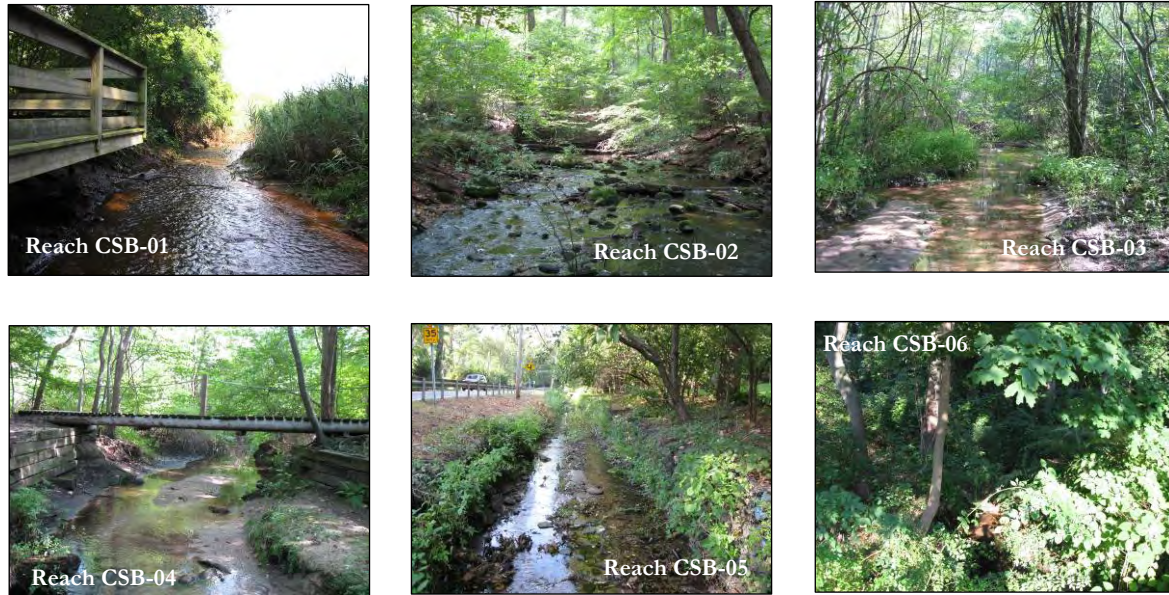
**Figure 10-1. Photographs of Cold Spring Brook Stream Reaches**

As depicted in the photographs in *Figure 10-1*, CSB-03 is the highest rated stream reach due to a wide vegetative buffer, adequate riparian cover, and good instream habitat. In contrast, CSB-05 has the lowest total score due to channel modification along the entire reach, the lack of canopy cover, poor instream habitat due to uniform channel properties, and limited stream buffer due to the proximity of Harbor Road.

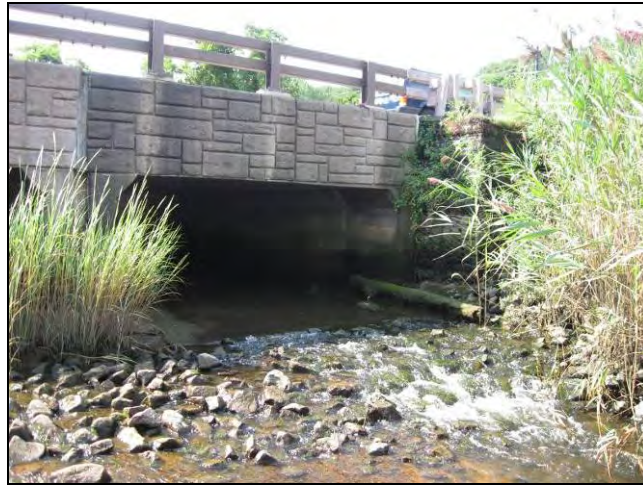
- **SC** – There are three stream crossings along the reach. SC-01 is the St. John's Pond dam at the upstream end of the reach. This dam is approximately 15 feet wide and 20 feet high and is a physical barrier to fish passage. Downstream of the dam is a plunge pool that collects and slows the water from the dam spillway. A concrete broad-crested weir approximately 2 feet in height (SC-02) was constructed approximately 25 feet downstream of the spillway to create the plunge pool. SC-03 is a twin box culvert beneath the Route 25A overpass. Each culvert is approximately 12 feet wide, 6 feet deep, and has a concrete bottom. The flow in both culverts was shallow (approximately 3 inches deep), which may impede fish passage under low-flow conditions.

*SC-03 is a twin box culvert beneath Route 25A along reach CSB-01.*

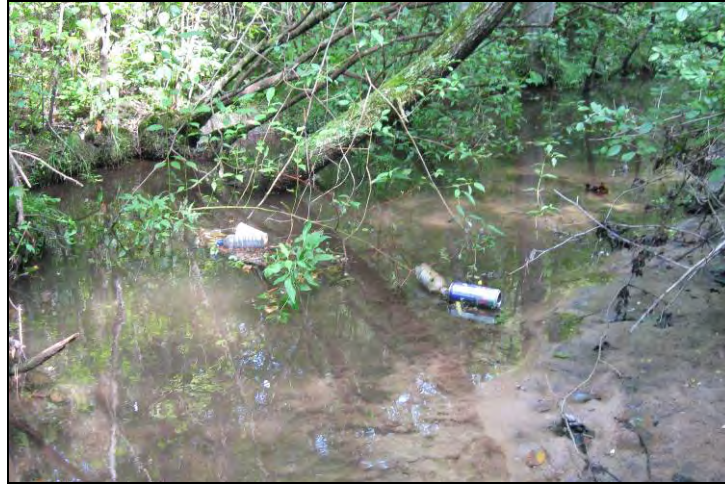
- TR – Although the reach habitat, stream buffers and floodplain are in optimal condition, the reach is characterized by areas of trash (bottles, cups, and various other household trash) in the stream and on the banks. The relatively minor amount of trash observed could be collected by volunteers with trash bags. This reach is a potential candidate for a stream cleanup.

*Evidence of household trash and debris, which was typical along CSB-03.*

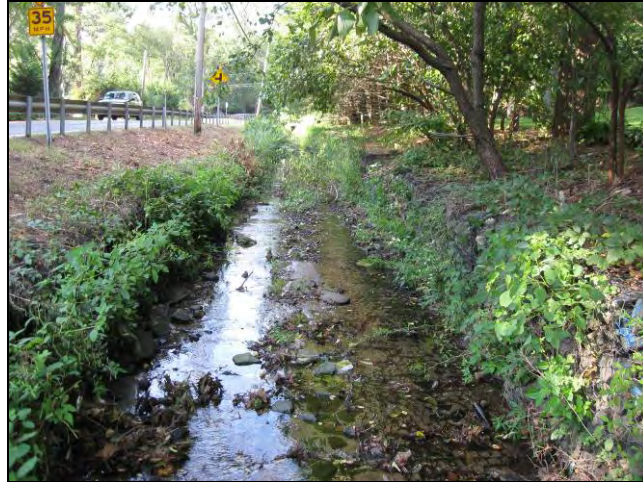
mesh used for stabilizing the channel bottom and vertical gabion walls for bank stabilization. The stream channel along this segment is approximately 8 feet wide and is greater than 500 feet long, flowing adjacent to Harbor Road.

*Reach CSB-05(CM-03) consists of a modified stream channel with gabion wall banks.*

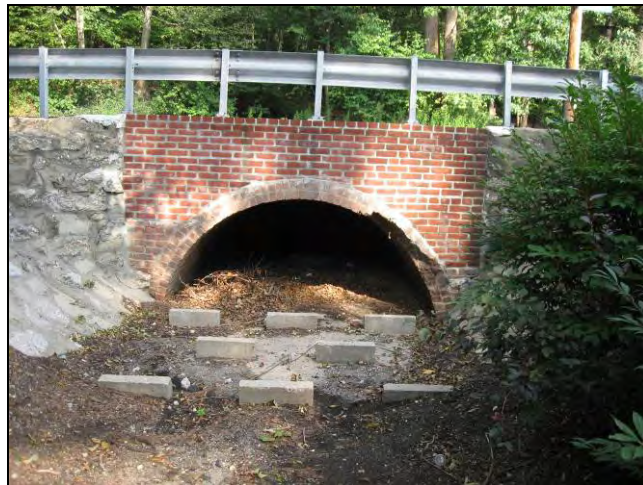
- OT – One outfall, OT-01, is present along this reach, which conveys flow from a mulched area and discharges inside the culvert along CM-02. Although the outfall is approximately 8 feet in diameter, no dry weather flow was observed.

*This arched culvert, OT-01, discharges to the box culvert that conveys Cold Spring Brook beneath Harbor Road.*

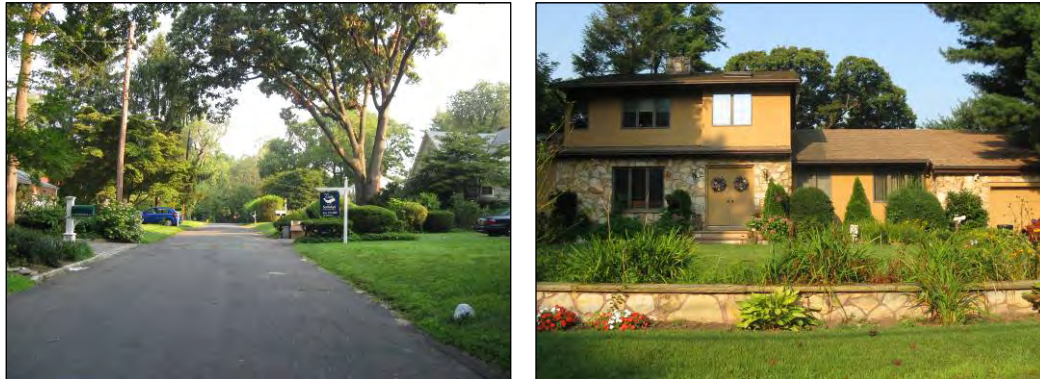
This neighborhood has low restoration potential. The majority of potential retrofits would need to occur at the lot level, such as installing rain gardens to promote stormwater infiltration and provide treatment. A small quantity of undeveloped land may be available south of the end of Egypt Lane where stormwater treatment could be implemented on a larger scale, although the ownership status is unknown.

*Views of Matinecock Lane showing intensively-landscaped lawns and planting beds adjacent to the relatively narrow road (left) and a typical residential lot (right).*

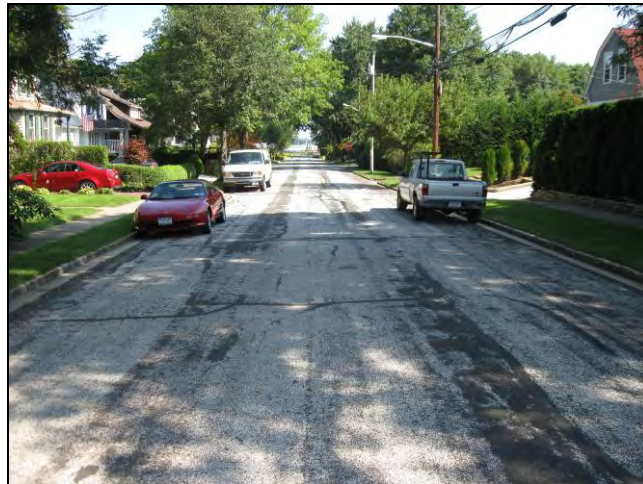
*Views of Ships Point Lane residences, which is a potential candidate for a green streets retrofit.*

This neighborhood is a good candidate for “green streets” retrofits. The typical street width in this neighborhood is 28 feet and had low utilization of on-street parking observed mid-morning on a weekday. A potential restoration candidate for this location includes stormwater curb extensions that can be easily retrofitted alongside the existing curb. Runoff from the street could be conveyed to these landscaped infiltration areas and would overflow into the existing drain inlets during larger storms. Since this street has a lot of unused on-street parking, the addition of curb extensions would not adversely impact existing parking. The curb extensions could provide stormwater infiltration, a more aesthetically pleasing roadway, and traffic calming.

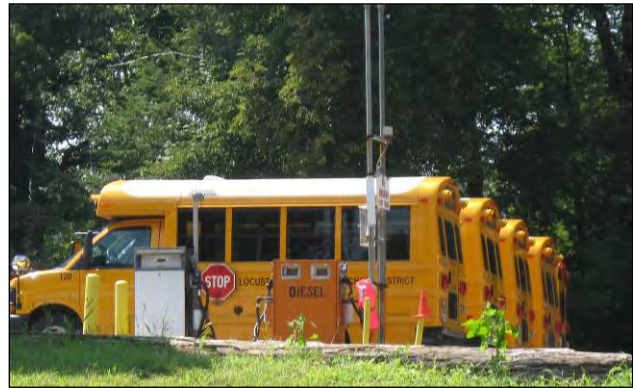
*Covering the outdoor fueling station at the bus maintenance facility would decrease the stormwater pollution potential of the fueling activities.*

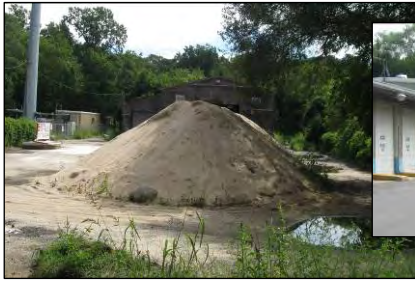
*Uncovered materials storage*

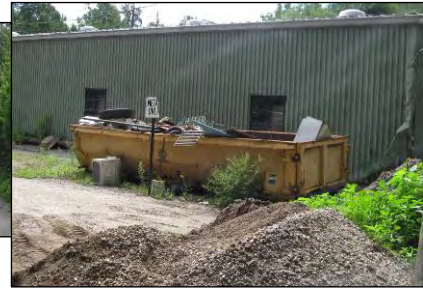
*Uncovered and overflowing dumpster*

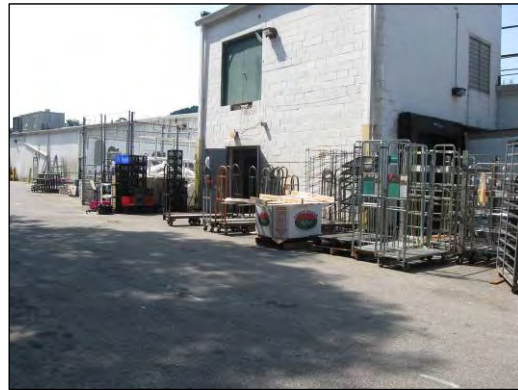
*Outdoor storage of materials*
