# STATE OF THE WATERSHED REPORT

## OYSTER BAY/COLD SPRING HARBOR

November 2009

**FUSS & O'NEILL**  
*Disciplines to Deliver*

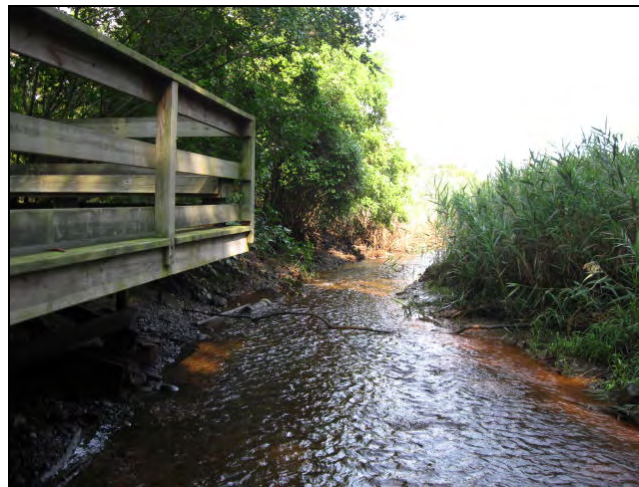
- IB – One area of impacted buffer is present on the left bank where a deck of approximately 15 feet in length was installed on the fish hatchery property. The deck was constructed to overhang the stream by approximately 2 to 4 feet.

*Impacted buffer along reach CBS-01 near the Cold Spring Fish Hatchery property.*

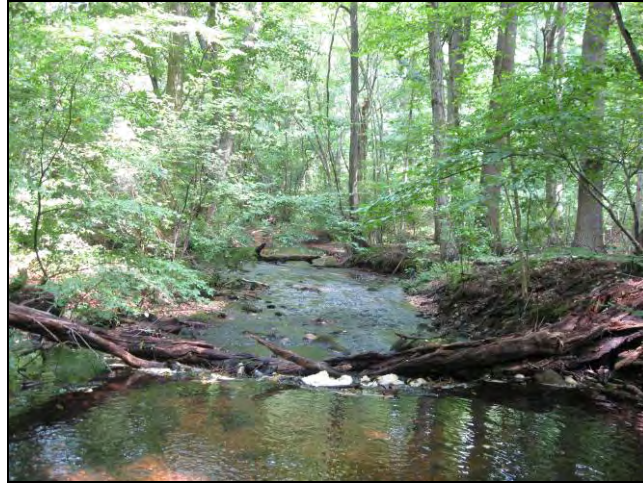
- RCH – The stream reach is of high quality and is characterized by wide stream buffers, a connected floodplain as evidenced by a large adjacent area of wetland seeps, and extensive canopy cover. The stream reach has optimal instream habitat characterized by submerged logs, shaded areas, large woody debris in the channel, and over 90% of the streambank shaded by native trees. The vegetated buffer width exceeds 50 feet along the main stream channel with little evidence of human impacts. The floodplain area is characterized by a mixture of wetland species and mature forest species.

*Reach CSB-02 is a high quality segment, characterized by optimal instream habitat, vegetated buffer, and floodplain connectivity.*

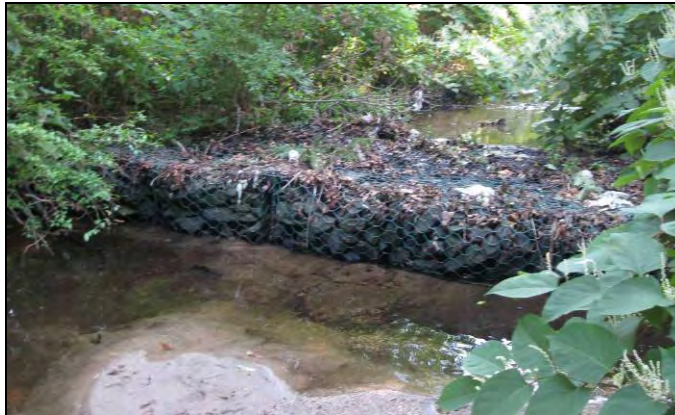
- SC – There is one stream crossing along reach SC-01, consisting of a gabion wall constructed across the stream channel at the upstream end of the reach. The gabion wall is approximately 2 feet tall, 6 feet long and 20 feet wide and spans the entire stream channel and banks. The gabion wall appears to have been constructed to prevent active headcutting at the location. Although the headcutting is no longer occurring, a pool exists downstream of the wall and shows signs of active downcutting.

*Gabion wall along reach CSB-04*

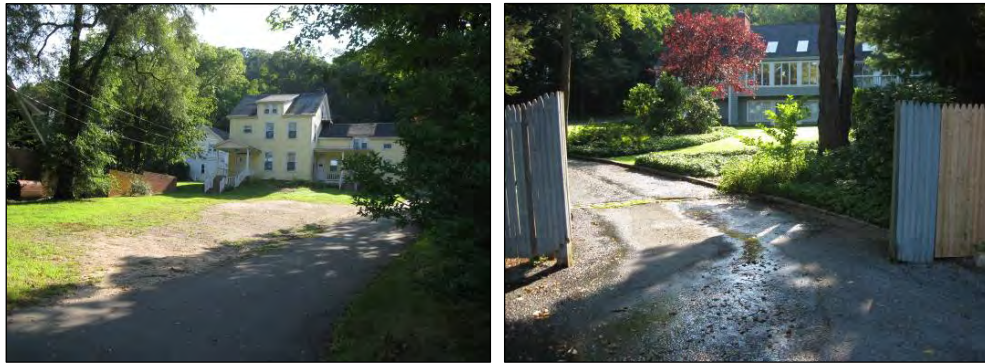
The pollution severity index of this neighborhood was moderate, with the potential for sediment discharge from the more densely developed areas and potential for lawn chemical discharge from the less densely developed lots. Additionally, the roadway itself is likely a significant pollutant source.

*Views of Harbor Road residences, including potential sediment source (left) and lawn irrigation runoff (right).*

The neighborhood restoration opportunity index for this neighborhood is generally low, since the sites are constrained by slopes, the location of the roadway, and little land is available between the roadway and the harbor. A notable exception is the Cold Spring Harbor State Park parking area, located at the southern end of this neighborhood, which is likely to be a significant sediment source and has reasonable restoration potential (see *Section 10.7*).

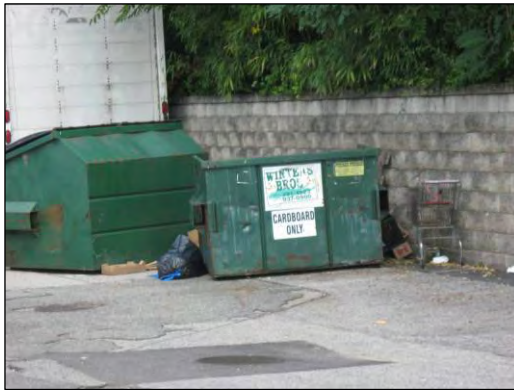
*Uncovered, overflowing dumpster*

Many stormwater pollutant sources were observed on this site. Vehicles, pallets, cardboard, and various bakery racks and store shelving are being stored outdoors uncovered in the rear of the buildings. The waste is not managed properly, and dumpsters were left uncovered with overflowing trash left in trash bags on the ground next to the dumpster. The parking lot and paved area behind the building is stained with oil and has a buildup of sediment.

The Pine Hollow Shopping Center is a confirmed hotspot. A follow-up inspection should be conducted. This and similar commercial retail centers should be included as targets for future education and outreach efforts. This site is also a good candidate for structural stormwater retrofits since the stormwater is conveyed toward the drainage system along Pine Hollow Road. Potential retrofits include parking lot bioretention, particularly along the perimeter of the parking lot adjacent to Pine Hollow Road.

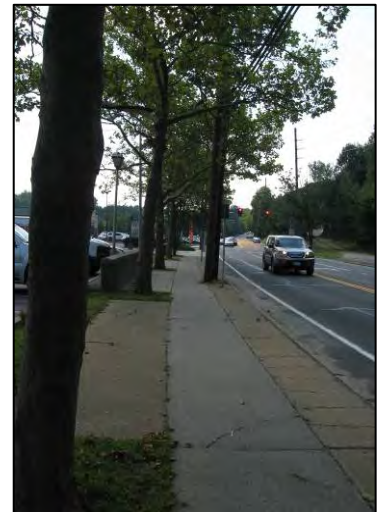
*Pine Hollow Shopping Center along Pine Hollow Road*

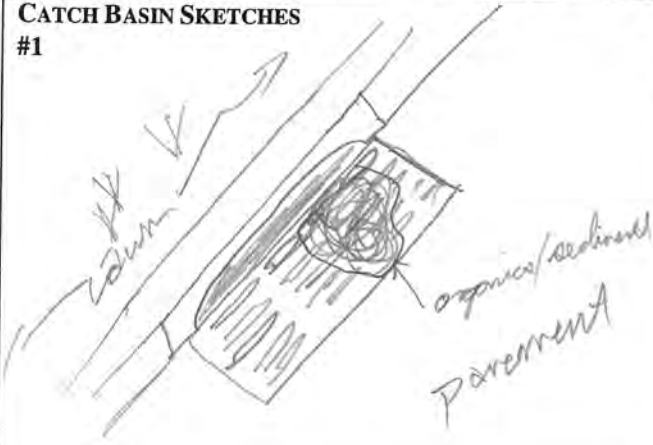
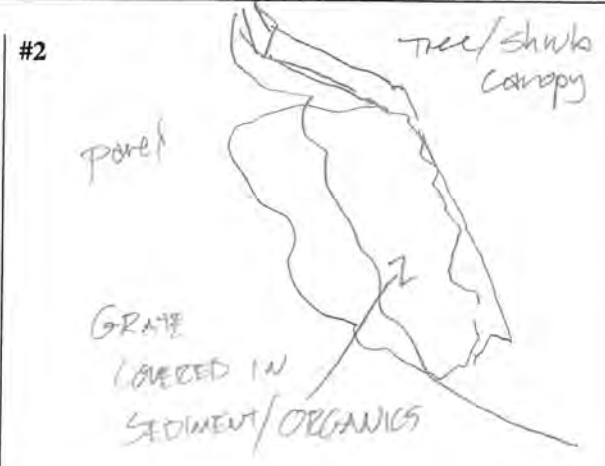
Bush/trees overhanging north side of road has prevented proper maintenance of storm drainage system.

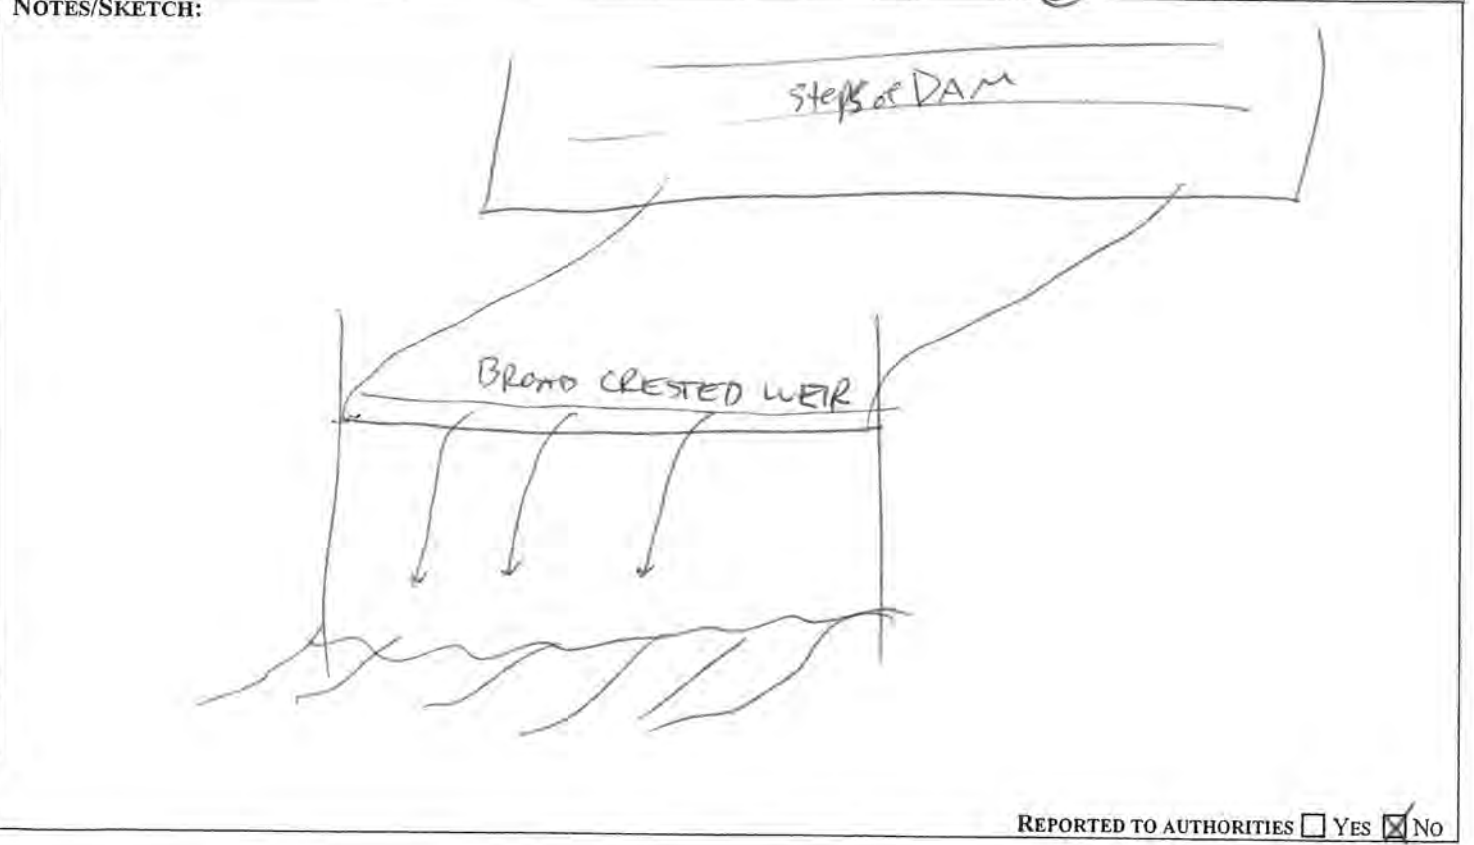
WATERSHED/SUBSHED: Cold Spring Brook DATE: 8/24/09 ASSESSED BY: KMB  
 SURVEY REACH ID: CSB-011 TIME: 10:26 AM/PM PHOTO ID: (Camera-Pic #) 45 005 # → 017  
 SITE ID: (Condition-#) SC-03 LAT 40° 51' 28.7" LONG 73° 27' 49.8" LMK \_\_\_\_\_ GPS (Unit ID) \_\_\_\_\_

If yes for fish barrier	EXTENT OF PHYSICAL BLOCKAGE: <input type="checkbox"/> Total <input checked="" type="checkbox"/> Partial <input type="checkbox"/> Temporary <input type="checkbox"/> Unknown	BLOCKAGE SEVERITY: (circle #)				
	CAUSE: <input checked="" type="checkbox"/> Drop too high Water Drop: <u>24</u> (in) <input type="checkbox"/> Flow too shallow Water Depth: _____ (in) <input type="checkbox"/> Other: _____	A structure such as a dam or road culvert on a 3rd order or greater stream blocking the upstream movement of anadromous fish; no fish passage device present.	A total fish blockage on a tributary that would isolate a significant reach of stream, or partial blockage that may interfere with the migration of anadromous fish.	A temporary barrier such as a beaver dam or a blockage at the very head of a stream with very little viable fish habitat above it; natural barriers such as waterfalls.

5	4	(3)	2	1

POTENTIAL RESTORATION CANDIDATE  Fish barrier removal  Culvert repair/replacement  Upstream storage retrofit  
 No  Local stream repair  Other:

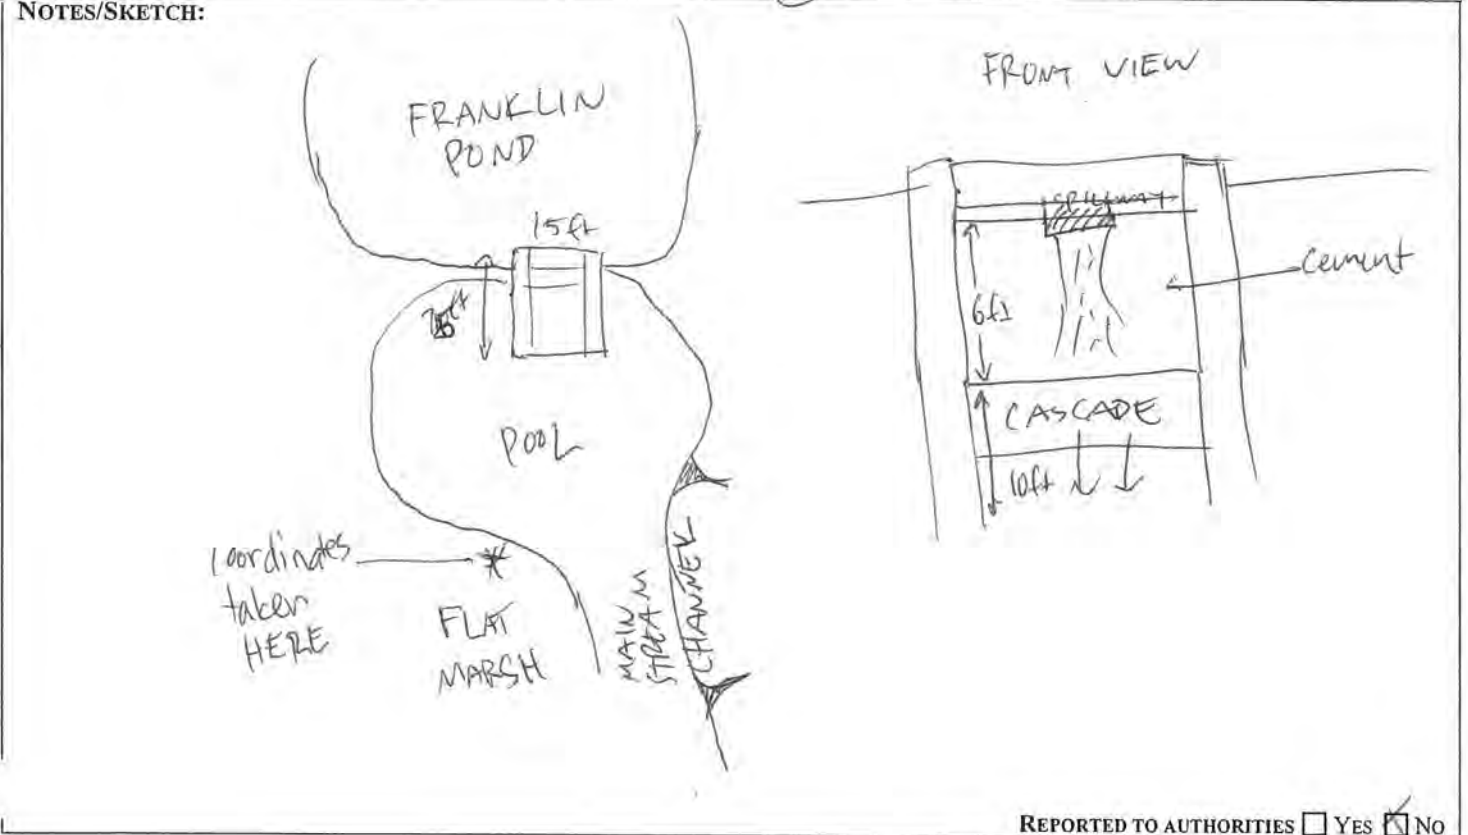
WATERSHED/SUBSHED: Cold Spring Brook DATE: 8/24/09 ASSESSED BY: KMB  
 SURVEY REACH ID: CSB-02 TIME: 12:16 AM/PM PHOTO ID: (Camera-Pic #) # 021  
 SITE ID: (Condition #) SC-01 LAT 40° 51' 8.3" LONG 73° 27' 38.5" LMK \_\_\_\_\_ GPS (Unit ID) \_\_\_\_\_

EXTENT OF PHYSICAL BLOCKAGE: <input checked="" type="checkbox"/> Total <input type="checkbox"/> Partial <input type="checkbox"/> Temporary <input type="checkbox"/> Unknown  CAUSE: <input checked="" type="checkbox"/> Drop too high Water Drop: <u>10ft</u> <input type="checkbox"/> Flow too shallow Water Depth: _____ (in) <input type="checkbox"/> Other:	BLOCKAGE SEVERITY: (circle #) A structure such as a dam or road culvert on a 3rd order or greater stream blocking the upstream movement of anadromous fish; no fish passage device present.			A total fish blockage on a tributary that would isolate a significant reach of stream, or partial blockage that may interfere with the migration of anadromous fish.	A temporary barrier such as a beaver dam or a blockage at the very head of a stream with very little viable fish habitat above it; natural barriers such as waterfalls.
	If yes for fish barrier	5	4	3	2

POTENTIAL RESTORATION CANDIDATE  Fish barrier removal  Culvert repair/replacement  Upstream storage retrofit  
 no  Local stream repair  Other:

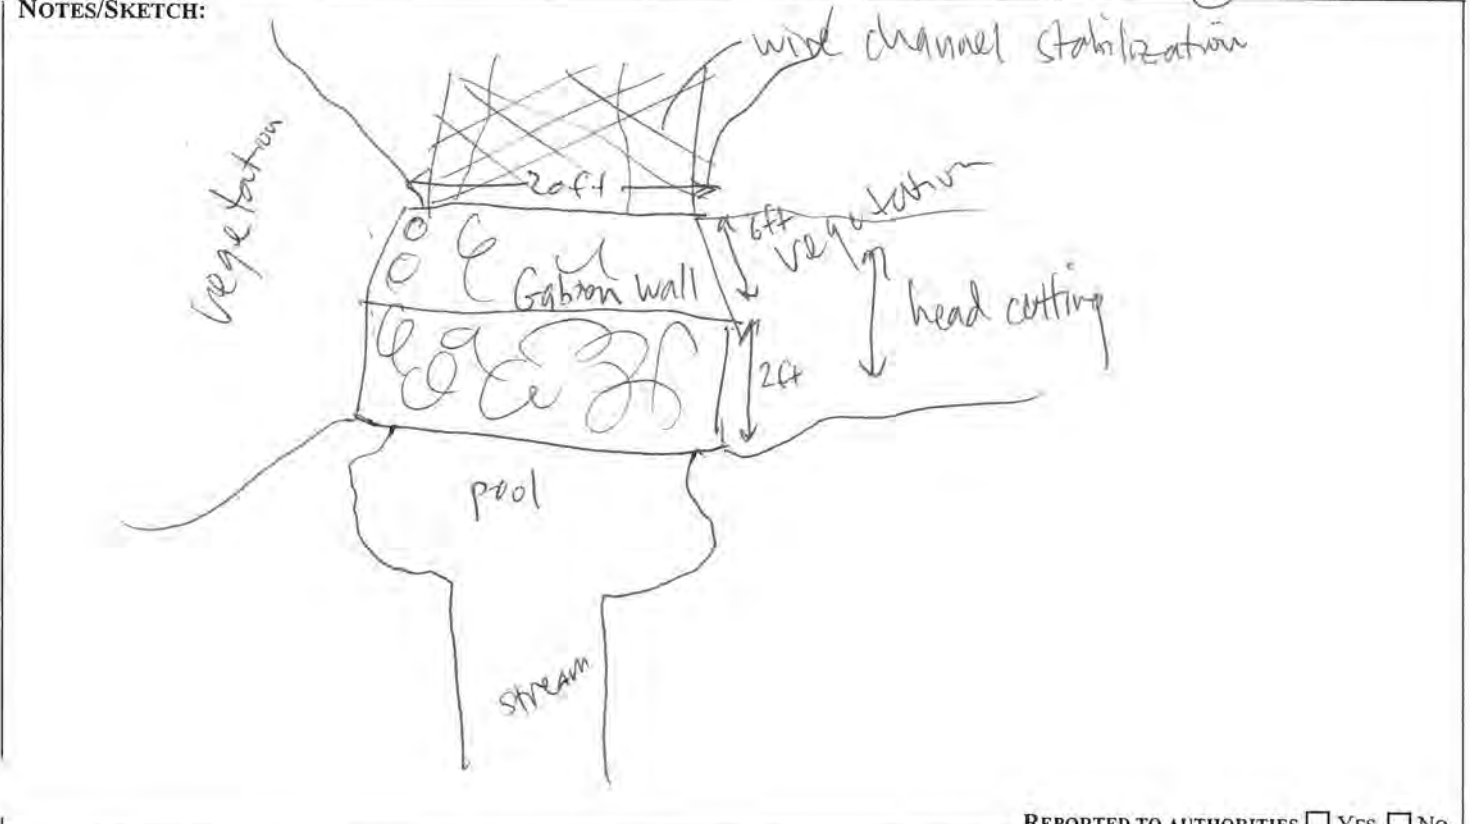
<i>If yes for fish barrier</i>	<b>EXTENT OF PHYSICAL BLOCKAGE:</b> <input type="checkbox"/> Total <input type="checkbox"/> Partial <input checked="" type="checkbox"/> Temporary <input type="checkbox"/> Unknown	<b>BLOCKAGE SEVERITY: (circle #)</b>		
	<b>CAUSE:</b> <input checked="" type="checkbox"/> Drop too high Water Drop: <u>24</u> (in) <input type="checkbox"/> Flow too shallow Water Depth: _____ (in) <input type="checkbox"/> Other: _____	A structure such as a dam or road culvert on a 3rd order or greater stream blocking the upstream movement of anadromous fish; no fish passage device present.	A total fish blockage on a tributary that would isolate a significant reach of stream, or partial blockage that may interfere with the migration of anadromous fish.	A temporary barrier such as a beaver dam or a blockage at the very head of a stream with very little viable fish habitat above it; natural barriers such as waterfalls.

5                      4                      3                      (2)                      1

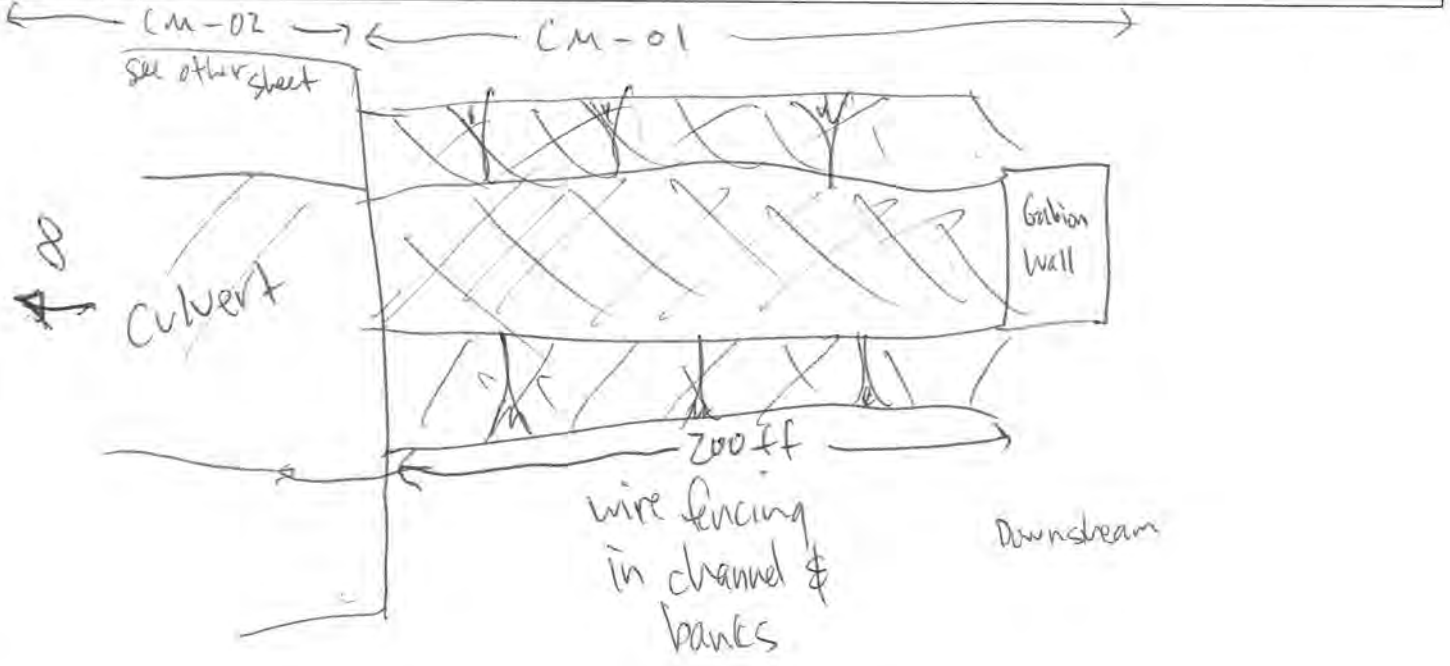
CHANNELIZATION SEVERITY: (Circle #)	5	4	3	2	1
	A long section of concrete stream (>500') channel where water is very shallow (<1" deep) with no natural sediments present in the channel.	A moderate length (> 200'), but channel stabilized and beginning to function as a natural stream channel. Vegetated bars may have formed in channel.			An earthen channel less than 100 ft with good water depth, a natural sediment bottom, and size and shape similar to the unchannelized stream reaches above and below impacted area.

NOTES: wire fence across entire channel and up sides of bank

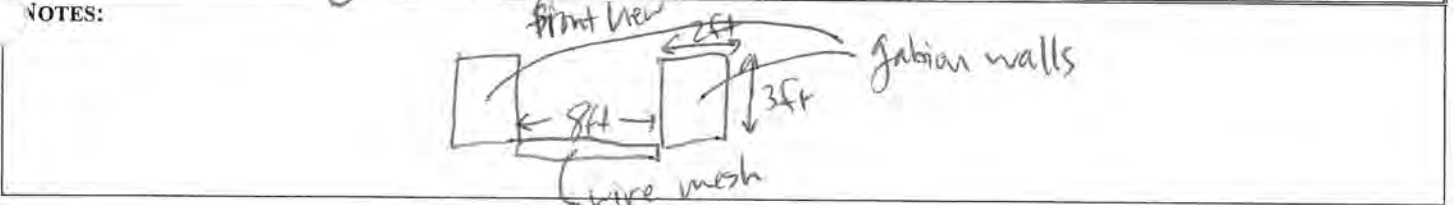
<b>CHANNELIZATION SEVERITY:</b> (Circle #)	A long section of concrete stream (>500') channel where water is very shallow (<1" deep) with no natural sediments present in the channel.	A moderate length (> 200'), but channel stabilized and beginning to function as a natural stream channel. Vegetated bars may have formed in channel.	An earthen channel less than 100 ft with good water depth, a natural sediment bottom, and size and shape similar to the unchanneled stream reaches above and below impacted area.
	5	4	3

no  De-channelization  Fish barrier removal  Bioengineering

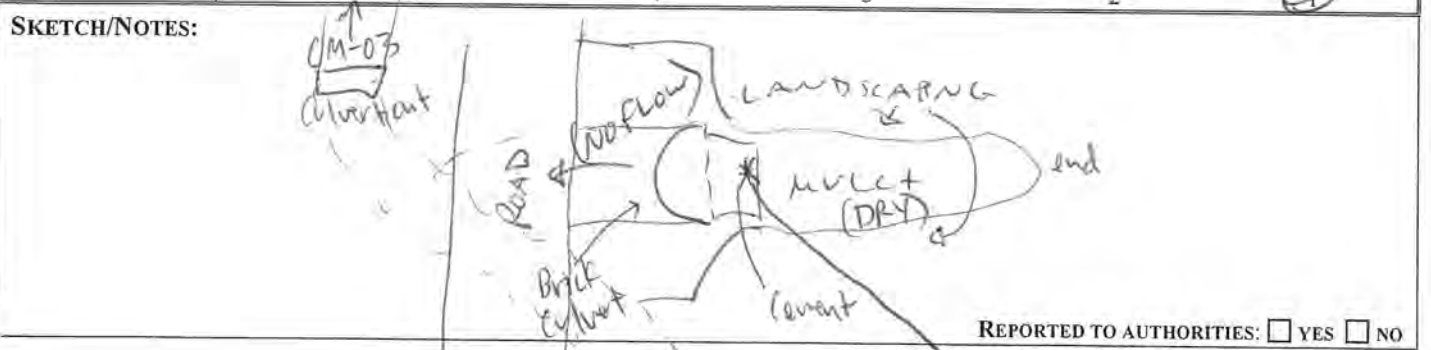
WATERSHED/SUBSHED: <u>Cold Springbk</u>		DATE: <u>8/24/09</u>	ASSESSED BY: <u>KMB</u>
SURVEY REACH ID: <u>CB-05</u>	TIME: <u>11:39</u> AM/PM	PHOTO ID: (Camera-Pic #) # <u>37</u>	
SITE ID (Condition-#): <u>OT-01</u>	LAT <u>40° 50' 27.5"</u> LONG <u>73° 27' 19.0"</u>	LMK _____	GPS: (Unit ID) _____

<b>OUTFALL SEVERITY:</b> (circle #)	Heavy discharge with a distinct color and/or a strong smell. The amount of discharge is significant compared to the amount of normal flow in receiving stream; discharge appears to be having a significant impact downstream.	Small discharge; flow mostly clear and odorless. If the discharge has a color and/or odor, the amount of discharge is very small compared to the stream's base flow and any impact appears to be minor / localized.	Outfall does not have dry weather discharge; staining; or appearance of causing any erosion problems.
	5	4	3

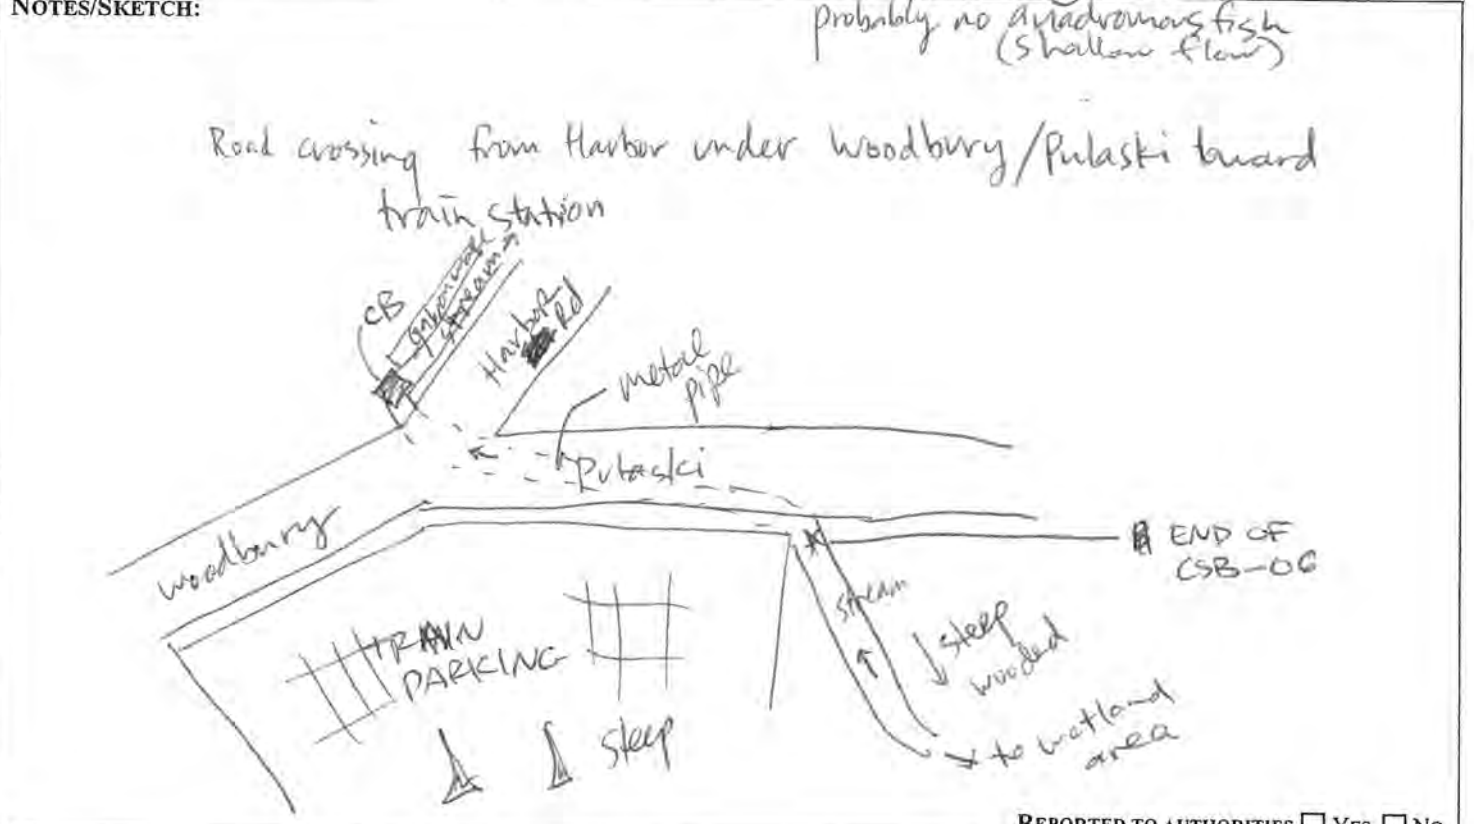
WATERSHED/SUBSHED: Cold Spring Brook DATE: 8/24/09 ASSESSED BY: \_\_\_\_\_  
 SURVEY REACH ID: CSB-05 TIME: 4:54 AM/PM PHOTO ID: (Camera-Pic #) \_\_\_\_\_ # 39  
 SITE ID: (Condition-#) SC-01 LAT 40° 50' 23.8" LONG 73° 27' 17.5" LMK \_\_\_\_\_ GPS (Unit ID) \_\_\_\_\_

If yes for fish barrier <b>EXTENT OF PHYSICAL BLOCKAGE:</b> <input checked="" type="checkbox"/> Total <input type="checkbox"/> Partial <input type="checkbox"/> Temporary <input type="checkbox"/> Unknown <b>CAUSE:</b> <input checked="" type="checkbox"/> Drop too high Water Drop: 24 (in) <input type="checkbox"/> Flow too shallow Water Depth: _____ (in) <input type="checkbox"/> Other:	<b>BLOCKAGE SEVERITY: (circle #)</b> A structure such as a dam or road culvert on a 3rd order or greater stream blocking the upstream movement of anadromous fish; no fish passage device present.			A total fish blockage on a tributary that would isolate a significant reach of stream, or partial blockage that may interfere with the migration of anadromous fish.	A temporary barrier such as a beaver dam or a blockage at the very head of a stream with very little viable fish habitat above it; natural barriers such as waterfalls.

5	4	3	2	1
